Army Lodging Wellness Recommendation

Fort Campbell - Final Submittal

August 19, 2003

3D/I

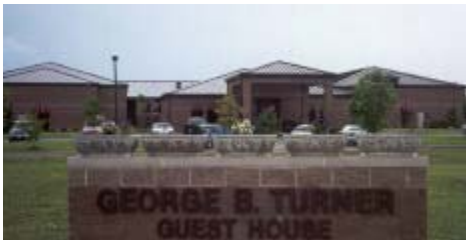
Building 82 and 83 (Turner Guest House)

Building 82 and 83, constructed in 1997, is the main Lodging facility complex. Building 82 is a single story structure serving as the administrative building, including the lobby, breakfast area, and administrative spaces. Building 83 is a 2-story structure housing 44 standard rooms and 91 extended stay rooms. This building also includes the back-of-house Lodging functions such as in-house laundry, maintenance, and receiving.

Although the facility was constructed within the last 5 years, it does not meet all of the current Army Lodging standards for the public and back-of-house spaces. Renovation is recommended to these spaces to provide a cohesive main Lodging facility.

The existing extended stay guest rooms in building 83 are oversized at 380 square feet each, but reconfiguration to meet current Army Lodging standards is not feasible based on building footprint and structure. Additionally, this building has more extended stay rooms and less standard rooms than required based on the demand. Our recommendation is to retain these rooms based on the age of this building, and to retain the existing kitchenettes in these extended stay rooms in lieu of removing these units to meet the standard room demand requirement.

The costs to make improvements and to bring the facility up to Army Lodging standards as noted will not exceed the 50% replacement cost.

Our recommendation is to retain buildings 82 and 83 in the Lodging inventory, with renovations to the public and back-of-house spaces. The

facility will continue to serve as the primary Lodging function in the Fort Campbell Wellness Solution and Lodging Master Plan.

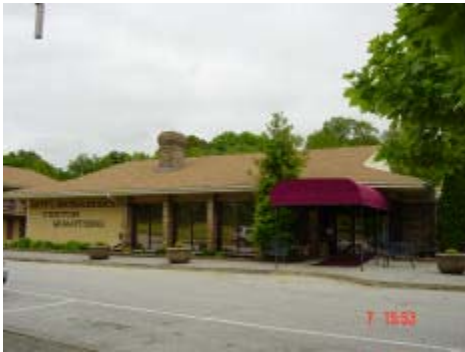
Buildings 1581, 1582, 1583, 1584 and 1585 (Richardson Guest House)

Buildings 1581, 1582, 1583, 1584 and 1585 were constructed in 1975. These buildings house 78 extended stay rooms and 4 family suites, are in poor condition, but meet the majority of the current Army Lodging standards. The cost to make condition assessment improvements will exceed the 50% replacement cost.

Our recommendation is to remove buildings 1581, 1582, 1583, 1584, and 1585 from the Lodging inventory, allowing the installation to determine an alternate use for these facilities. These facilities will be removed from the Fort Campbell Wellness Solution and Lodging Master Plan.

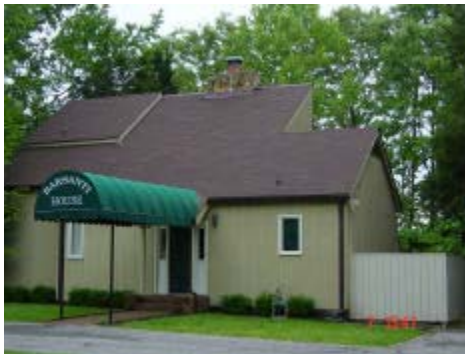
Building 1595 (Barsanti House)

Building 1595, constructed in 1975 is a single story structure housing a single DVQ. This building is in poor condition and does not meet current Army Lodging standards. The cost to make condition assessment improvements will exceed the 50% replacement cost.

Our recommendation is to remove building 1595 from the Lodging inventory, allowing the installation to determine an alternate use for this facility. This facility will be removed from the Fort Campbell Wellness Solution and Lodging Master Plan.

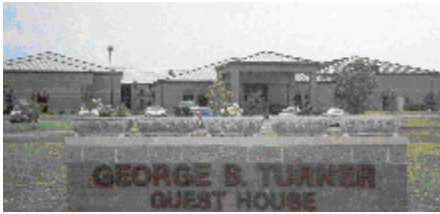
Bldg 82 in center. Bldg 83 on sides and to the rear.

This building is in good condition for both the Condition Assessment and Function Criteria. In this building the Condition Assessment costs include the wellness items and the Renovation Cost includes functional renovations but not Condition Assessment cost due to the limited nature of the renovation. Therefore in the Cost Analysis the sum of the Condition Assessment and Renovation cost is used for the ratio to the Replacement Cost

Even though the sum of the Condition Assessment & Renovation Cost to Replacement Cost Ratio is greater than 50%, renovation of Building 82 is recommended. Building 82 and 83 are built as a complex with Building 82 providing support spaces for the guest rooms located in Building 83. The combined ratio of this building complex (Buildings 82 and 83) is only 36.7%. It is therefore recommended to retain Building 82 as continued support for this complex, and make necessary condition assessment and renovation improvements.

- Analysis: Foundation is composed of grade beams in compacted soil. No clear failures can be seen from perimeter. Foundation is in good condition.

- Analysis: The structure is a metal truss frame construction with steel purlins. CMU walls support the roof structure. Gutters are exterior to the roof with the downspouts exposed. The superstructure is in good condition.

- Analysis: The exterior walls are brick veneer in good condition. However, in a few areas near the ground, the brick "wicks" water during a rain causing a mold mildew problem inside.

- Analysis: Wall finishes are a combination of paint and vinyl wall covering. The public restrooms are also paint with a vinyl wall covering wainscot. All finishes are in good condition.
- Recommendation: Paint drywall surfaces and recover walls with vinyl wall coverings at end of their useful life.

- Analysis: Most of the building has carpet. The restrooms, breakfast area, and door entry areas have ceramic tile. All floor coverings are in good condition.
- Recommendation: Replace carpet at the end of its useful life.

- Analysis: Ceilings are predominately acoustical ceiling tile. Painted gypsum board is in the restrooms and as a ceiling accent in the lobby. All are in good condition.
- Recommendation: Paint the gypsum board ceilings.

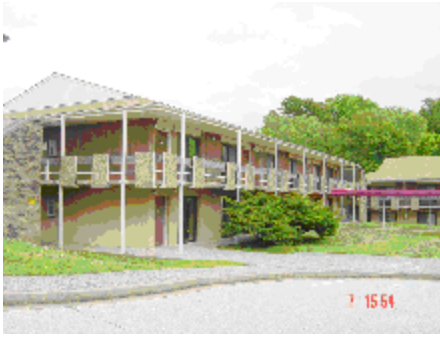
Building 1584 was constructed in 1975. The 8,996 square foot facility contains 22 lodging units: 22 single bedroom units with full bathroom and kitchenette. The building is functioning as 22 extended stay rooms.

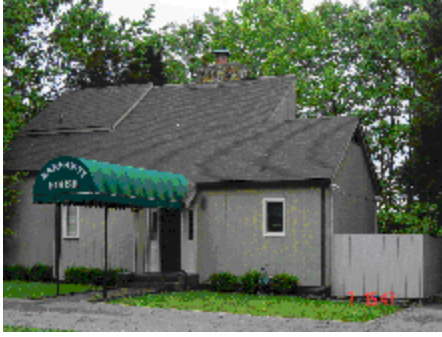
Building 1595 was constructed in 1982. The 1,178 square foot facility is residential in nature and is used as a DVQ. It contains 1 lodging unit: 2 bedrooms with adjoining baths, a full kitchen, dining and living room. The building is functioning as 1 extended stay room.
